## NEW MEXICO ENVIRONMENT DEPARTMENT

Re: **Fortis Construction/ Project Antelope; CGP; SIC 1541; NPDES Compliance Evaluation  
Inspection; NPDES #NMR1000CX; November 1, 2017**

### NPDES Compliance Inspection Report

## NPDES Construction General Permit Inspection Report – State of New Mexico

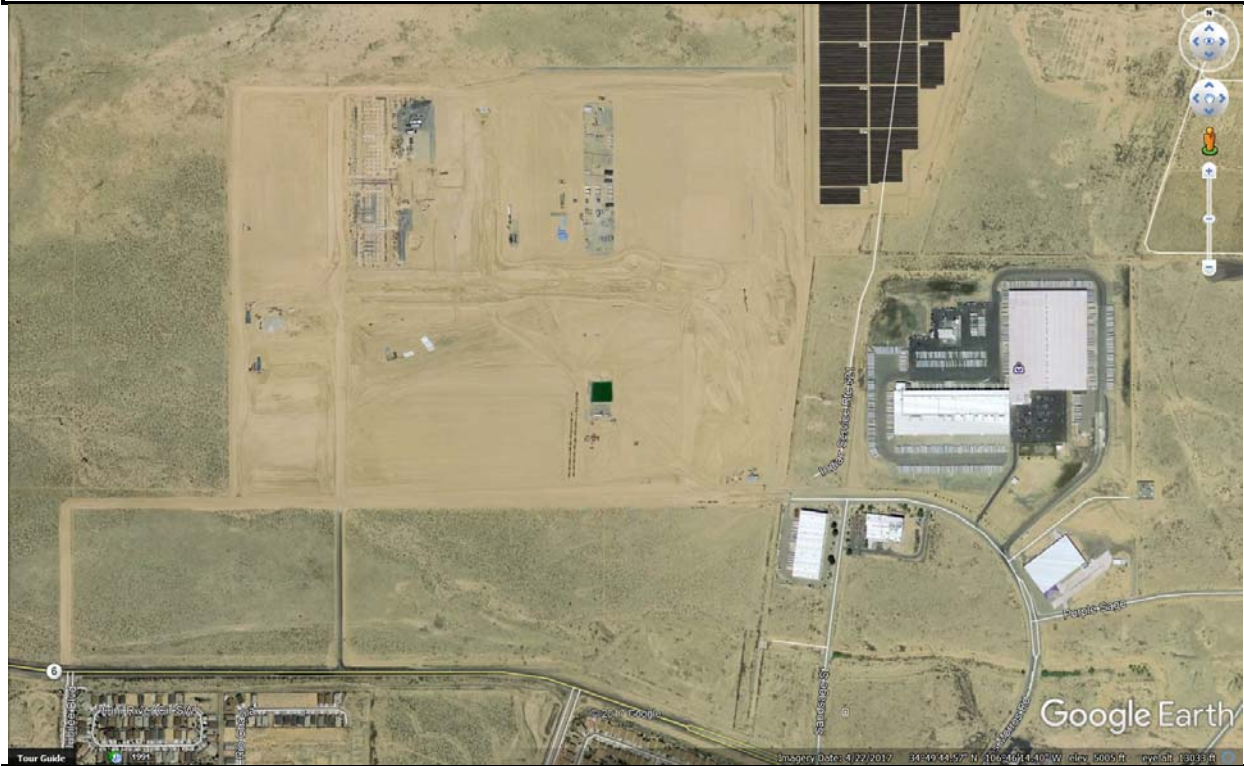
NMED/SWQB Official Photograph Log Photo # 1		
Photographer: Google Earth	Date: 4-22-17	Time: unknown
City/County: Los Lunas/Valencia		State: New Mexico
Location: Project Antelope		
Subject: Aerial view of project in April 2017

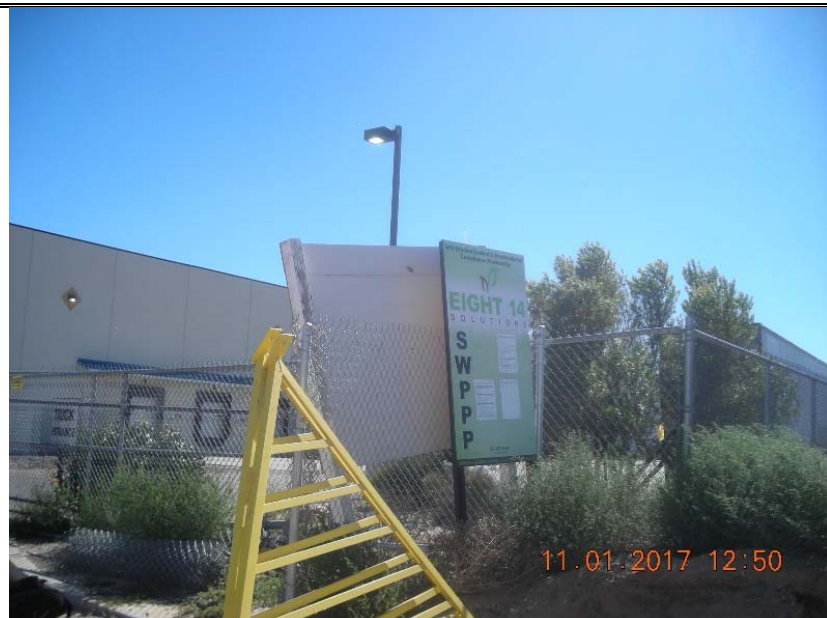
The public NOI posting was facing the inside of the site located inside the access control and was therefore not visible to the general public.

- Part 1.5 SWPPP Public posting was located inside a fence with access control and facing inwards (photo 2).

NMED/SWQB Official Photograph Log Photo # 2		
Photographer: Jennifer Foote	Date: 11-1-17	Time: 12:50 pm
City/County: Los Lunas/Valencia		State: New Mexico
Location: Project Antelope		
Subject: SWPPP NOI Posting facing away from the public, inspector is standing inside the site looking out

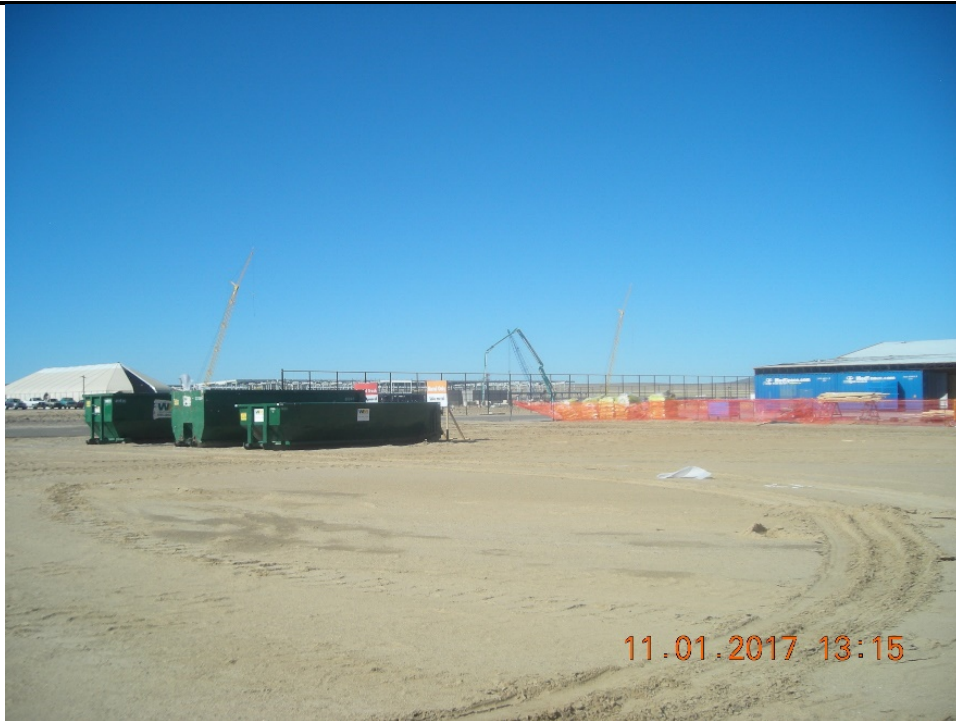
Fortis Construction maintains the BMPs. In general the site was neat and orderly. There was a 10,000 gal DOT fuel tank covered by a SPCC, as well as several smaller tanks onsite. Porta Potties were staked down, however the high winds and sandy soil in open areas require stronger tie-downs. Dumpsters were not covered and packing materials were observed to blow out of a dumpster. The contractor stated that materials had been ordered to cover the dumpsters.

NMED/SWQB Official Photograph Log Photo # 3		
Photographer: Jennifer Foote	Date: 11-1-17	Time: 1:15 pm
City/County: Los Lunas/Valencia		State: New Mexico
Location: Project Antelope		
Subject: Packing materials blowing out of uncovered dumpster

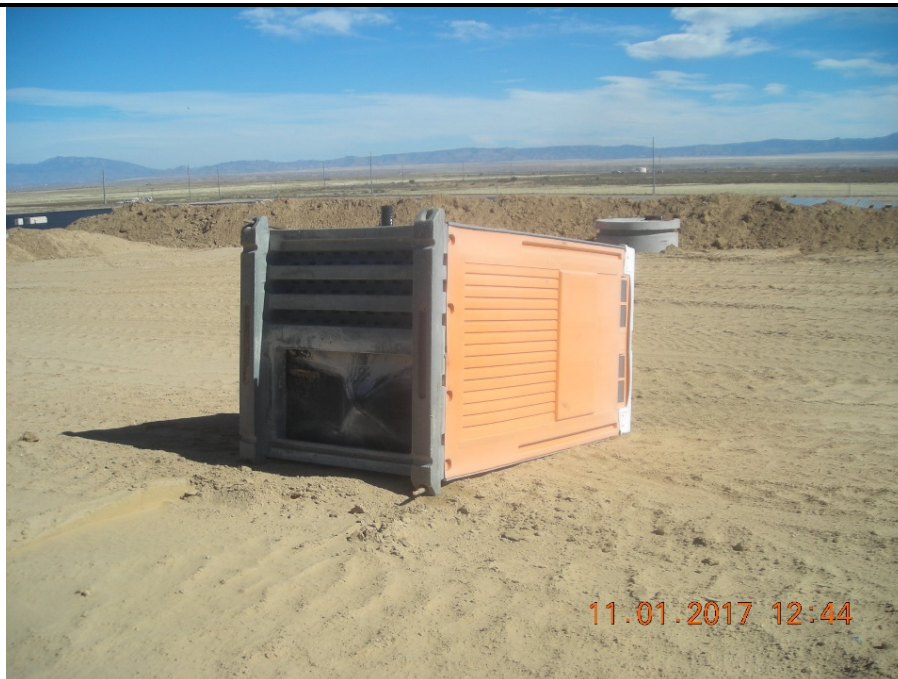
NMED/SWQB Official Photograph Log Photo # 4		
Photographer: Jennifer Foote	Date: 11-1-17	Time: 12:44 pm
City/County: Los Lunas/Valencia		State: New Mexico
Location: Project Antelope		
Subject: Porta potty with insufficient anchors for high wind

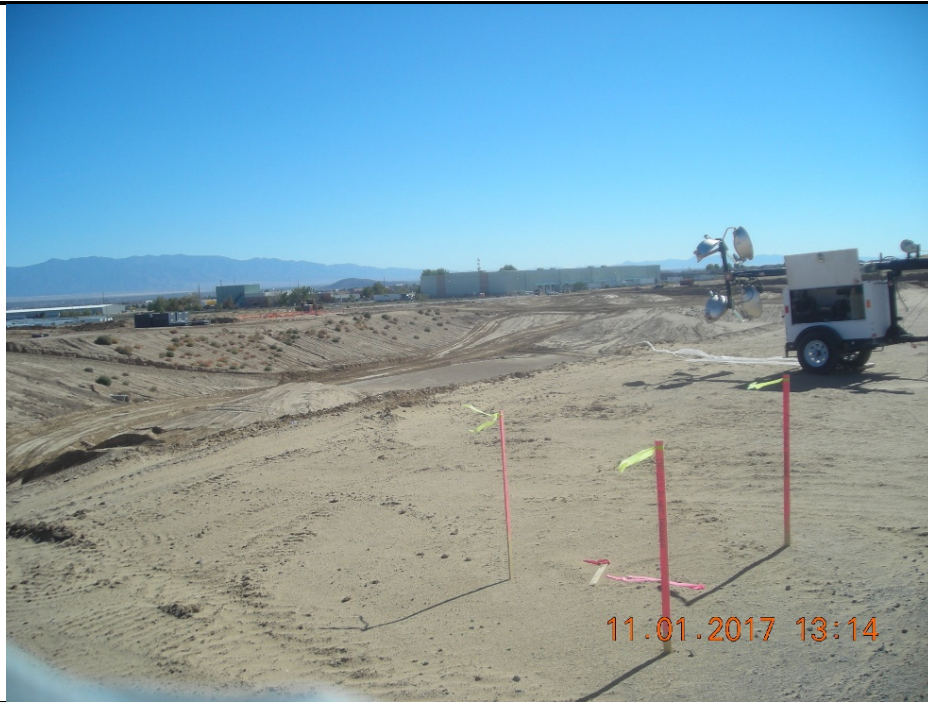
NMED/SWQB Official Photograph Log Photo # 5		
Photographer: Jennifer Foote	Date: 11-1-17	Time: 1:14 pm
City/County: Los Lunas/Valencia		State: New Mexico
Location: Project Antelope		
Subject: Stormwater retention pond within site limits

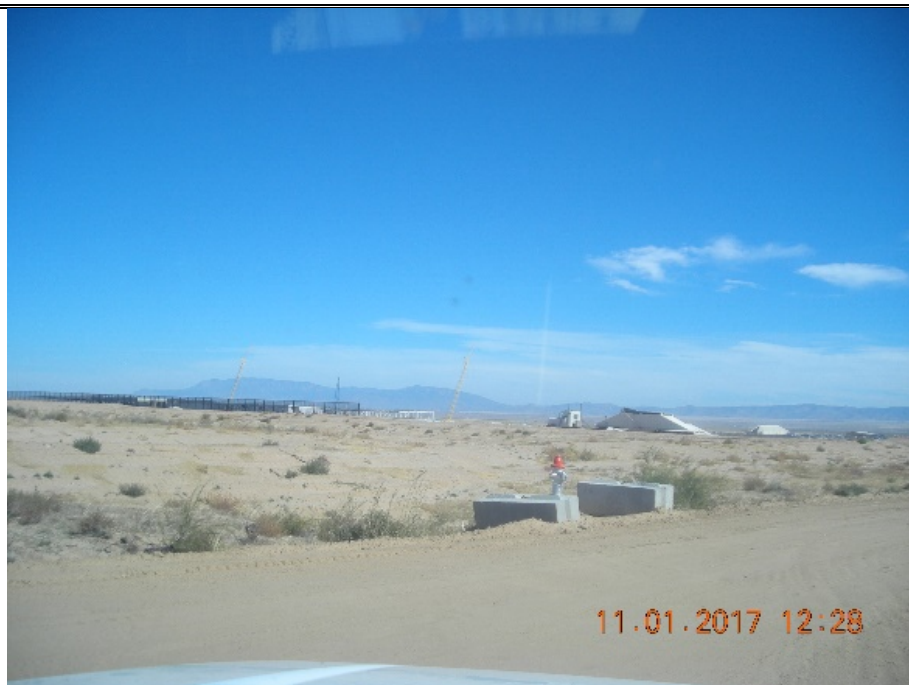
There were no plans for stabilizing areas outside of the project limits that the contractor disturbed at request of the adjacent land owner such as utility corridor and the new drainage ponds. The plan did not include any specific information on final stabilization for the site.

NMED/SWQB Official Photograph Log Photo # 6		
Photographer: Jennifer Foote	Date: 11-1-17	Time: 12:28 pm
City/County: Los Lunas/Valencia		State: New Mexico
Location: Project Antelope		
Subject: Stormwater retention pond and utility corridor outside site limits with no documented plans for stabilization

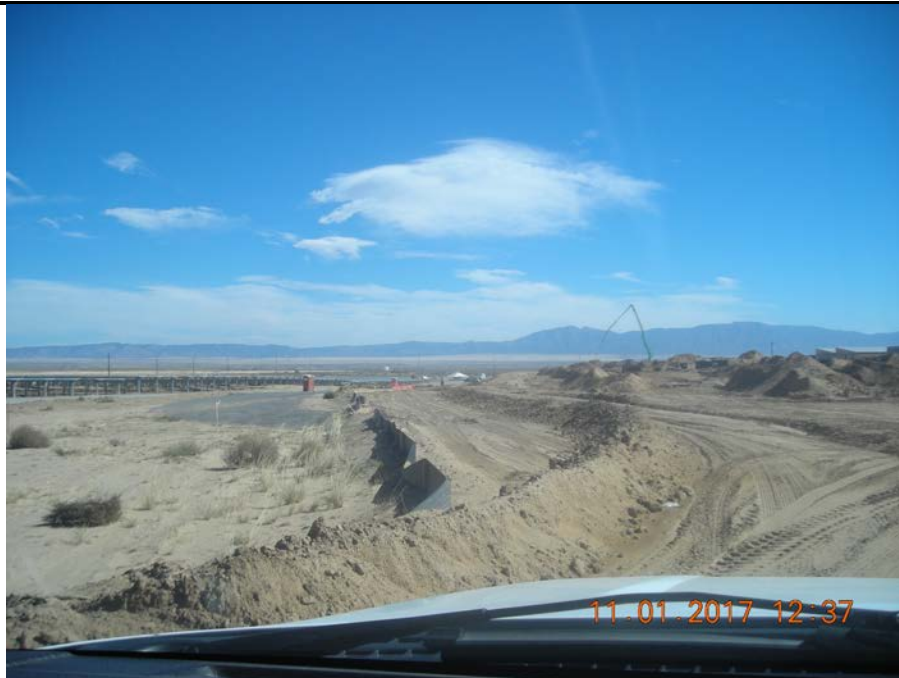
Silt fences on the north side of the site had been damaged by recent grading operations and was not yet repaired. Check dams were not included in the original design but were installed along the road on the south side after they were found to be necessary.

NMED/SWQB Official Photograph Log Photo # 7		
Photographer: Jennifer Foote	Date: 11-1-17	Time: 12:37 pm
City/County: Los Lunas/Valencia		State: New Mexico
Location: Project Antelope		
Subject: silt fence on north side of site damaged by grading

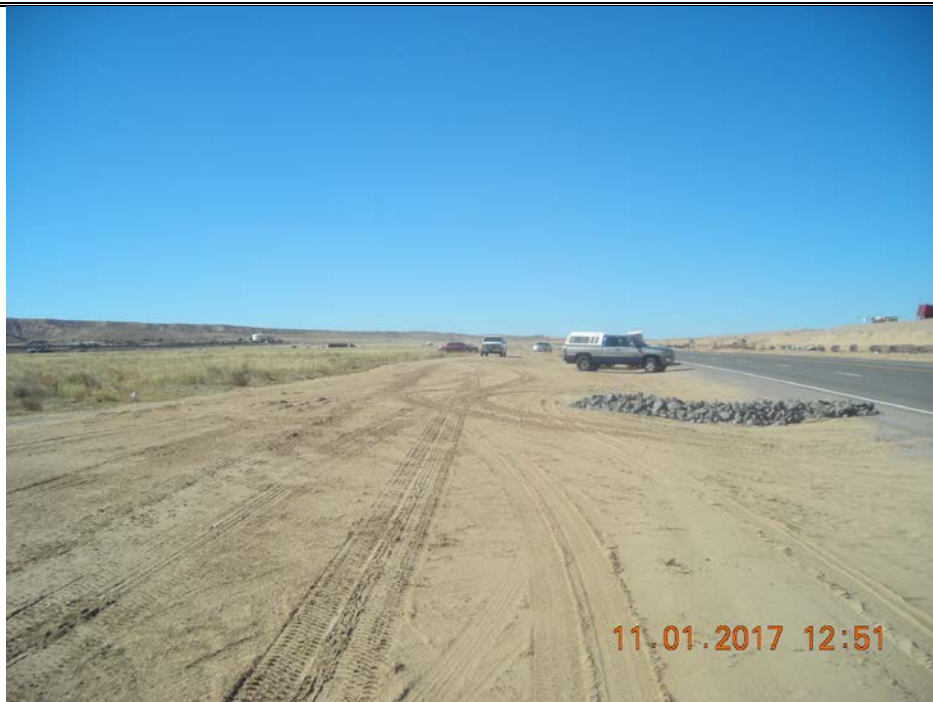
NMED/SWQB Official Photograph Log Photo # 8		
Photographer: Jennifer Foote	Date: 11-1-17	Time: 12:28 pm
City/County: Los Lunas/Valencia		State: New Mexico
Location: Project Antelope		
Subject: New check dams on south side of site
